Vibration and Infrared Inspection Report

Prepared for: John Smith, XYZ Company
Prepared by: Nick Engelhardt, Renown Monitoring Services
June 24, 2013
Work Order # 500234

Re: Vibration Analysis Report

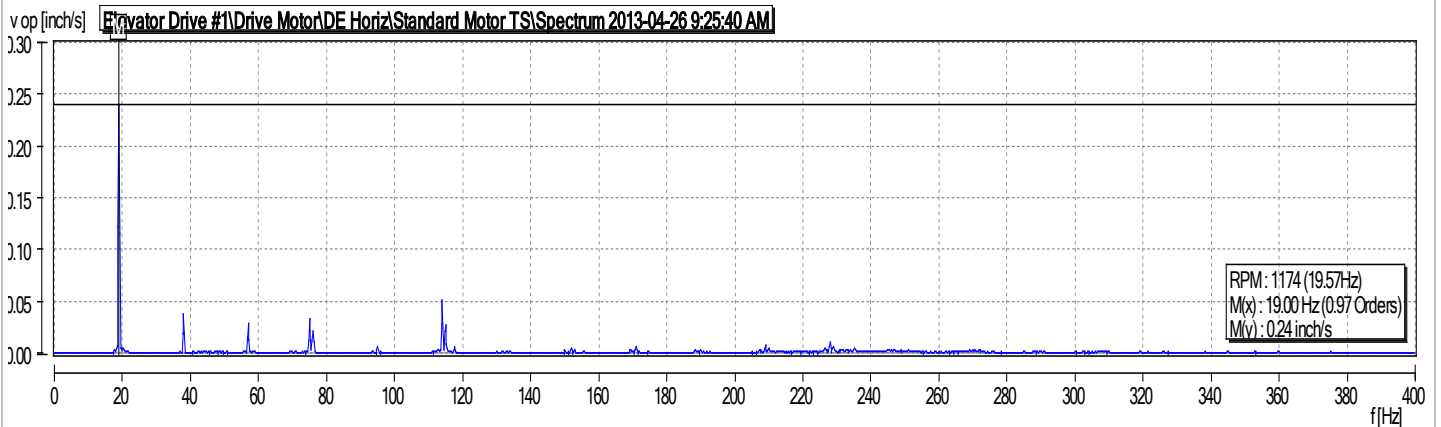
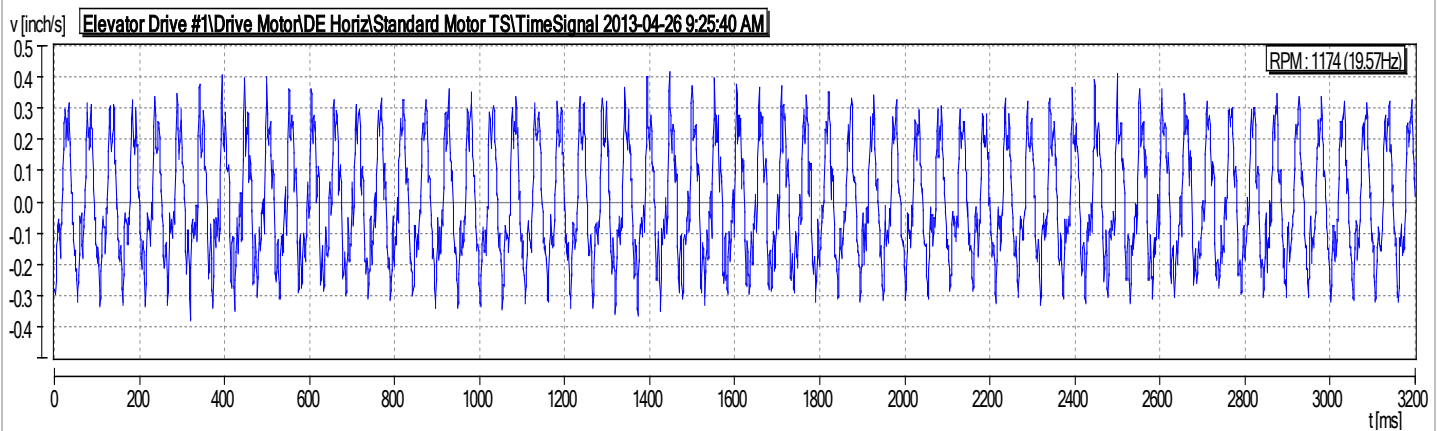
EQUIPMENT: Elevator Drive # 1 - Motor

Elevator Drive # 1	WEG 25hp 575v 1185rpm s/n BC25656	2	4	Vibration frequency indicates coupling misalignment. Recommend corrective laser alignment of motor and gearbox. (alignment performed on June 23, 2013)
EEM-01 Drive unit	Siemens 147kw 1185rpm s/n T4115788001001/2005	2	4	Vibration frequencies indicate structural looseness. Recommend increasing rigidity of motor mount.

DESCRIPTION: Elevated 1x vibration level detected at drive end of motor indicates possible misalignment at the coupling. Corrective laser alignment performed on June 23, 2013. (see results below)

RECOMMENDATIONS: Continue to monitor.

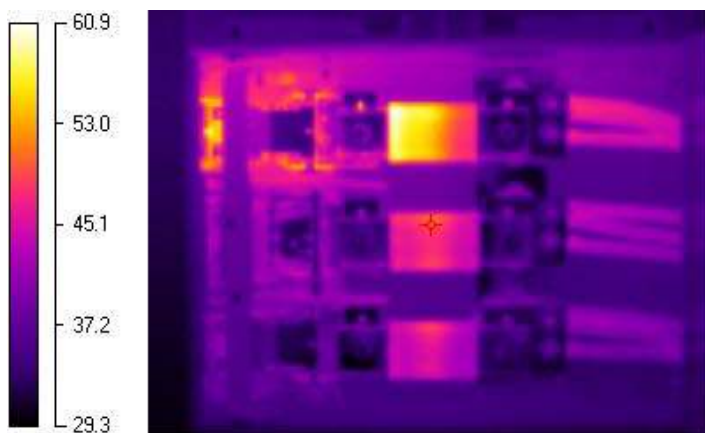
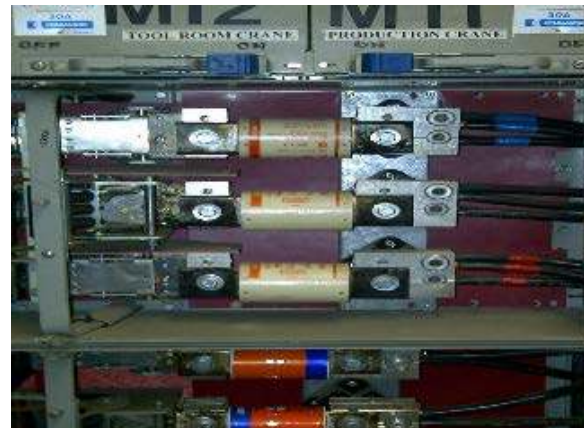
Dist. Panel E Feed

Elevated temperature detected at top fuse.

Repair Priority Medium

Image Date 5/21/2013 9:13:26 AM
Target Temperature 49.4 °C
Emissivity 0.90
Reflected Temp OFF
Distance 1 Meter

Replace fuse, check connection, tighten, retest and continue to monitor.

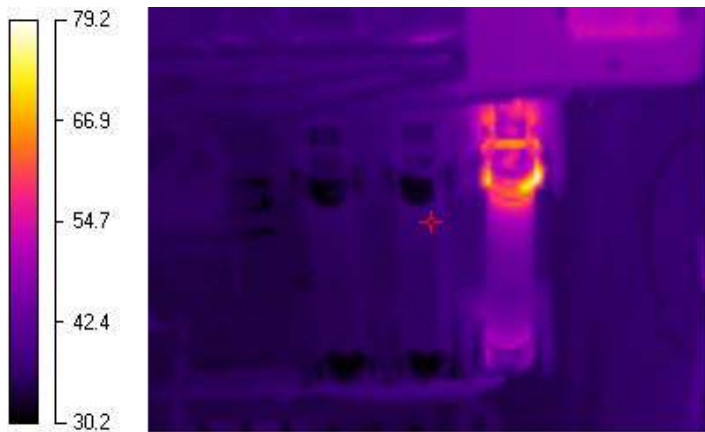
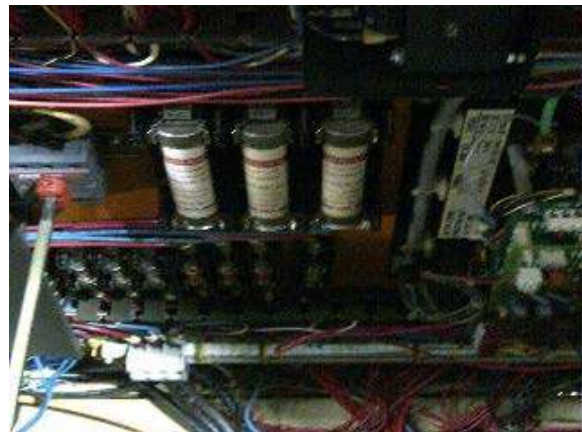
Press P4 Feeder Control Panel

Elevated temperature detected at right fuse, line side.

Repair Priority Medium

Image Date 5/21/2013 10:07:50 AM
Target Temperature 37.1 °C
Emissivity 0.90
Reflected Temp OFF
Distance 1 Meter

Replace fuse, check connection, tighten, retest and continue to monitor.
