Technical Bulletin: Regrooving Elevator Sheaves

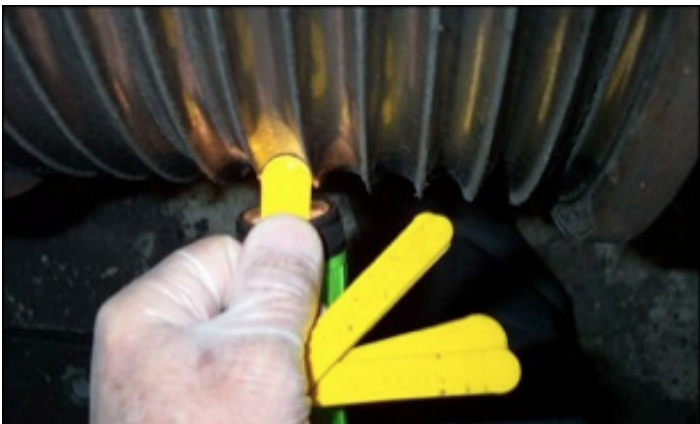
Grooves being checked with groove gauges

Worn sheaves place additional wear on ropes, which in turn add wear onto sheaves, setting up a cycle of destruction for both. Replacing or regrooving sheaves may be necessary to prevent this. Check groove profiles annually to verify the fit between ropes and the sheave. A proper fit means good traction. Without good traction, you’re either sacrificing rope life, sheave wear, or both. Take the time to perform a quick check and measure whether all the ropes sitting in their sheave grooves are at equal height.

Drive sheave grooves being checked with groove gauges for 5/8" rope

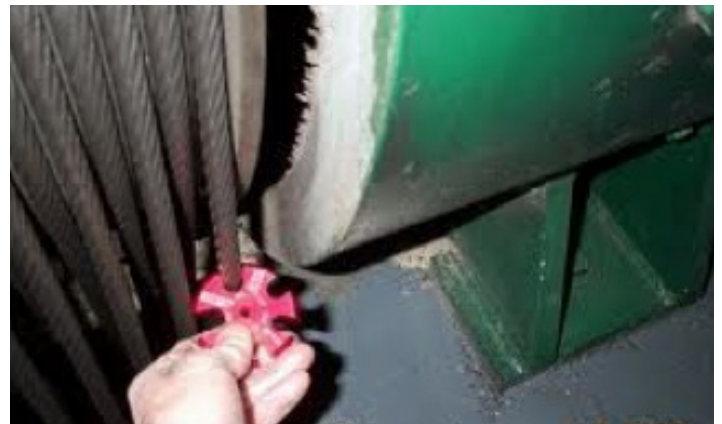
Rope measuring

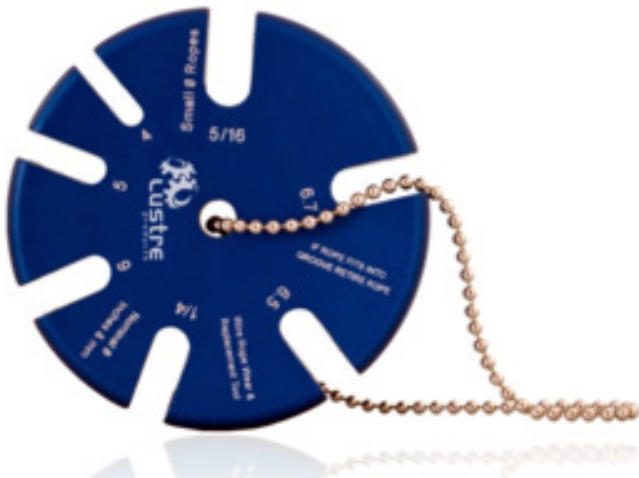
Rope gauge

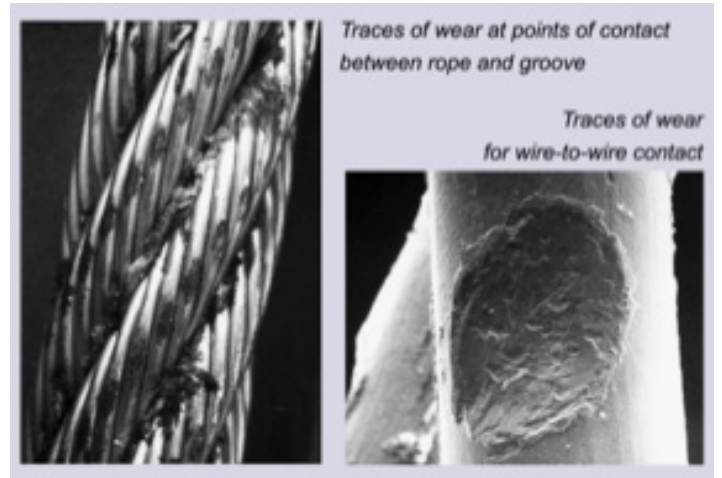
Example of rope damage

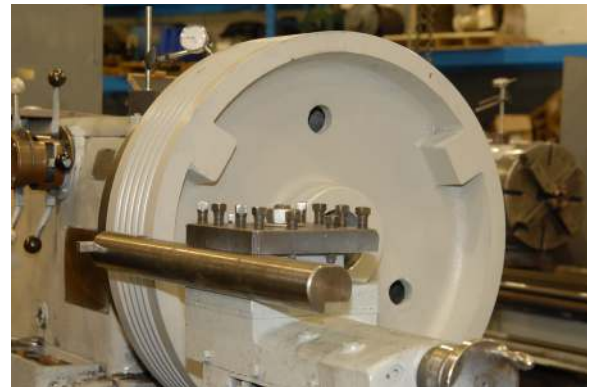
Sheave on lathe in Renown's shop
